# Third Five-Year Review Report

## Queen City Farms Superfund Site

City of Maple Valley  
King County, Washington

September 2008

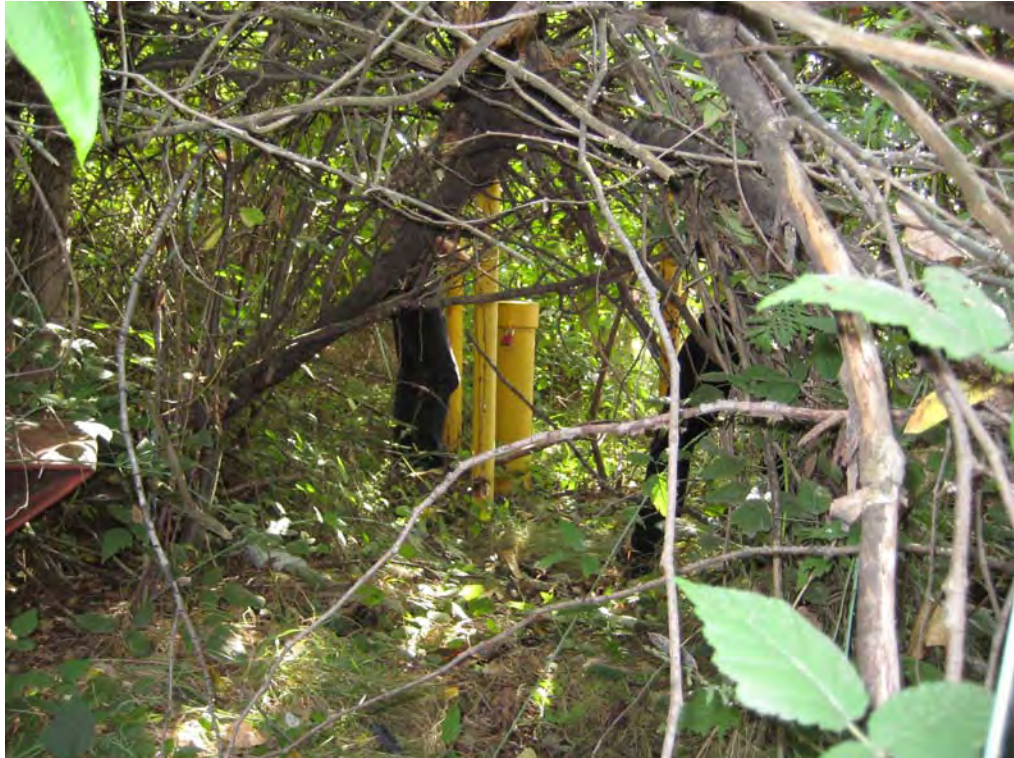
Photo 1: Monitoring Well MW-1 (4-Tek) is currently obstructed by vegetation. The property owner will be informed of the need to provide adequate access.

Recommendations / Follow-up Actions (continued)	Responsible Party	Oversight Agency	Milestone Date	Affects Protectiveness	
				Current	Future
MW-1: Restore proper access to this well	QCF	EPA	March 2009	No	No
MW-3: Properly close and abandon this well	QCF	EPA	March 2009	No	Yes
MW-4: Locate well & check for abandonment	QCF	EPA	March 2009	No	Yes
MW-5: Repair well cap so it can be locked	QCF	EPA	March 2009	No	Yes

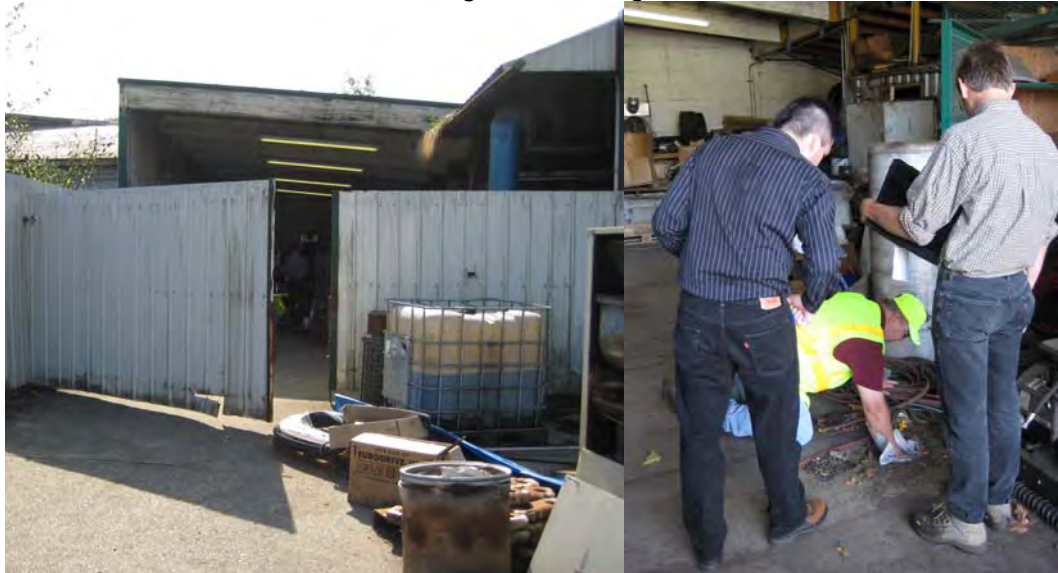
Photos 2-3: Former Monitoring Well MW-3 was located near the center of this shop, by the former 4-Tek facility. The property owner will be informed of the need to close the well in accordance with Washington State regulations.

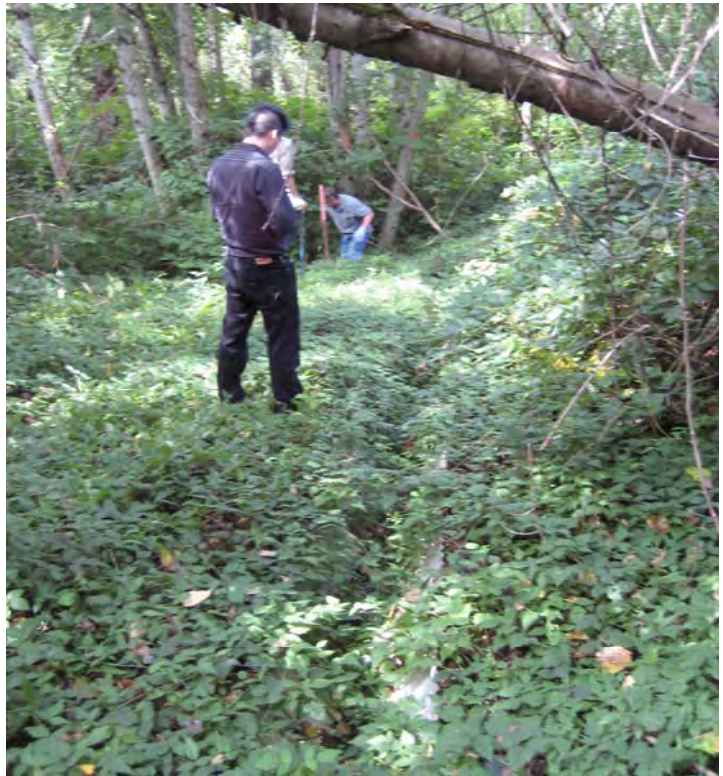
Photo 4: The drainage channel from the cap over the Containment Area.

The flowpath for the drainage is currently unobstructed, but the vegetation will need to be trimmed back before obstruction begins.

The discharge for this drainage channel is located by the figures in the background, and is in the direction of Queen City Lake.

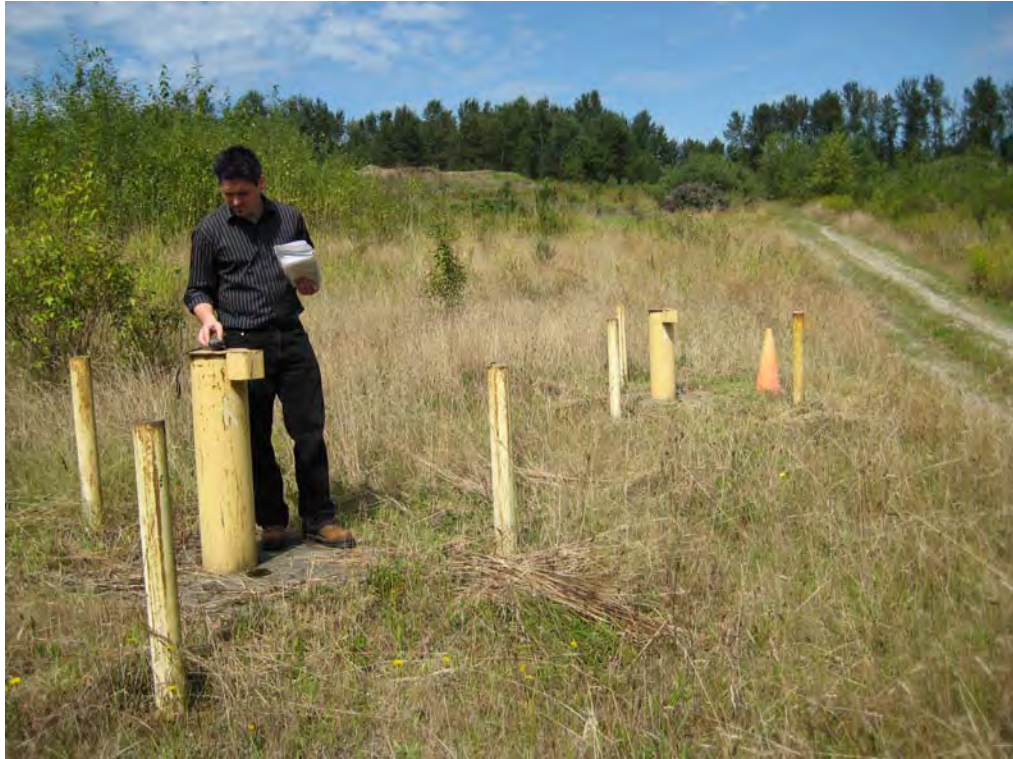
Photo 6: Monitoring Well R-2a, facing north toward monitoring well cluster D.

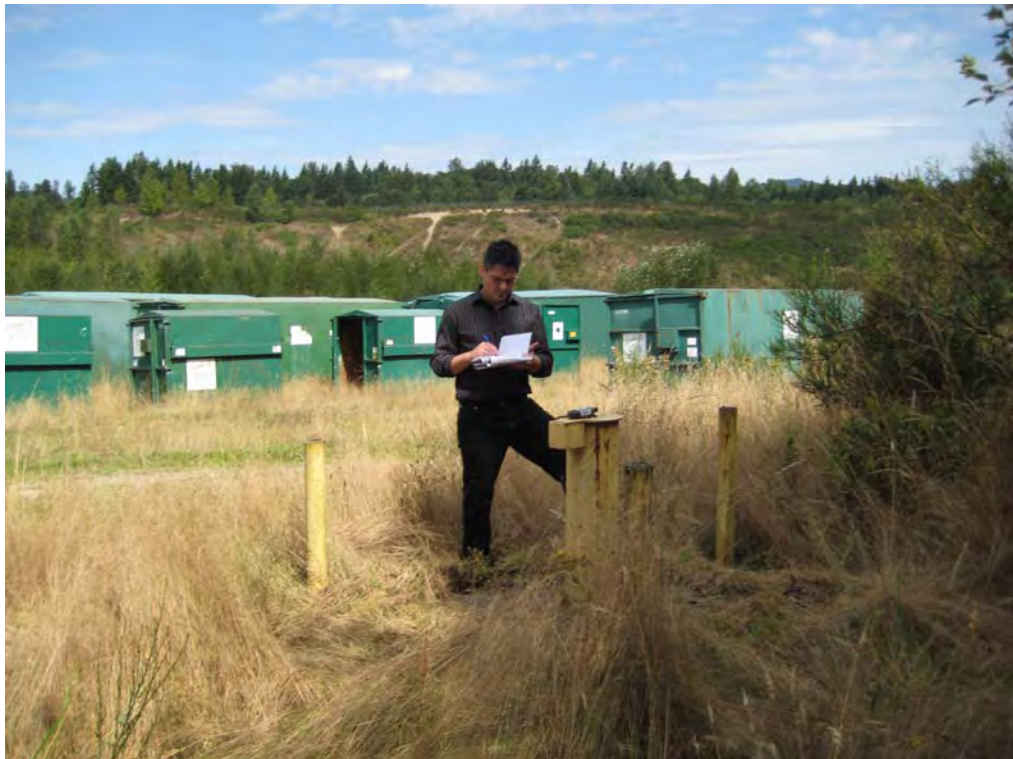
Photo 6: Monitoring Well S-2, facing north-northeast toward the Containment Area, which is located on the rise that can be seen in the background of this photograph.

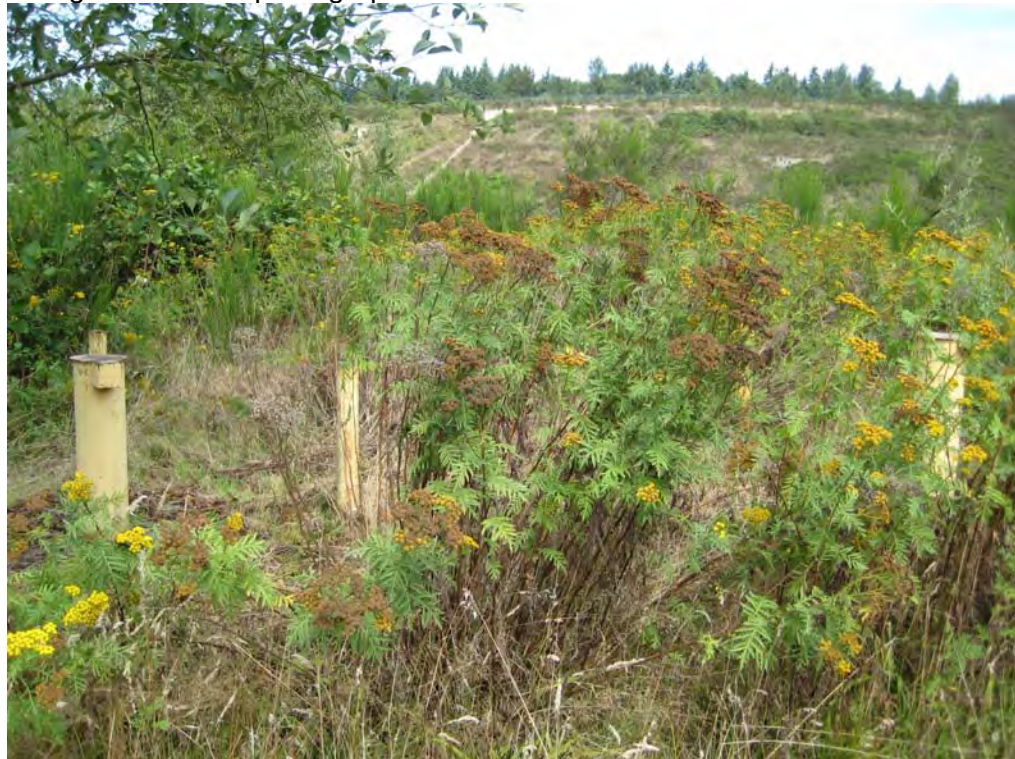
Photo 7: Monitoring wells U-2 [left] and U-3a [right] facing north-northeast toward the Containment Area, which is located on the rise that can be seen in the background of this photograph.

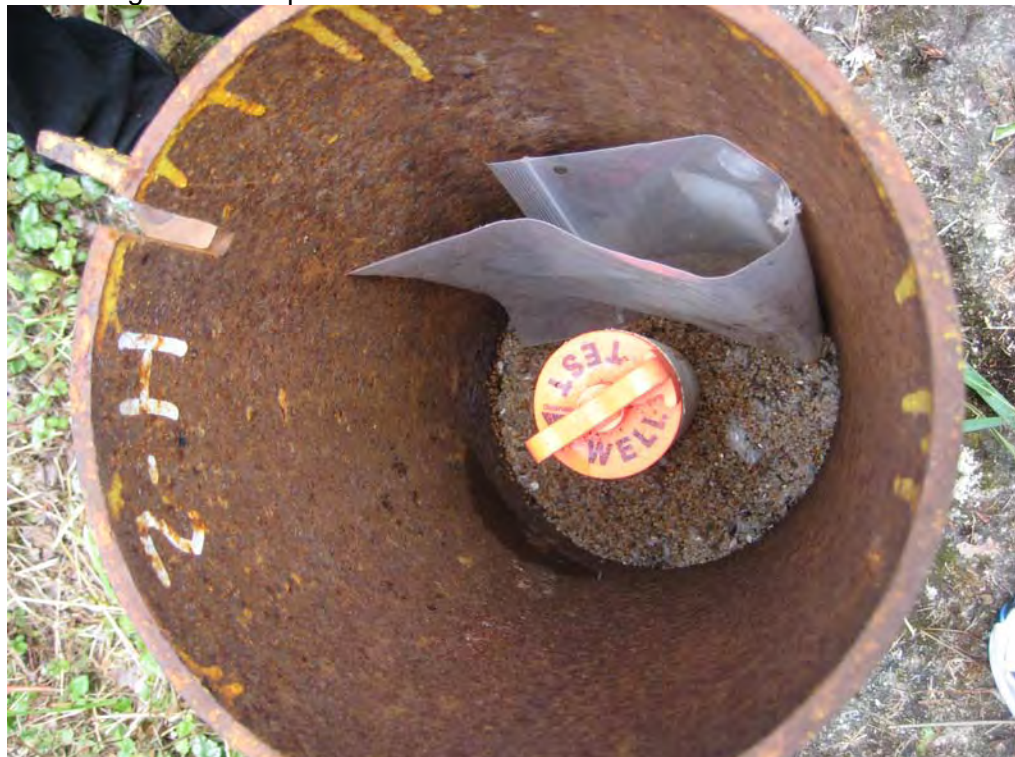
Photo 8: A view inside the well cap of monitoring well H-2, and was typical of all of the monitoring wells we opened that were associated with the Containment Area.
